**SEISMIC ASSESSMENT OF PRE-1970S
REINFORCED CONCRETE STRUCTURE**

A thesis
submitted in partial fulfilment
of the requirements for the Degree
of
Master of Engineering
in the
University of Canterbury
by
Eric Hertanto

University of Canterbury
Christchurch, New Zealand

2005

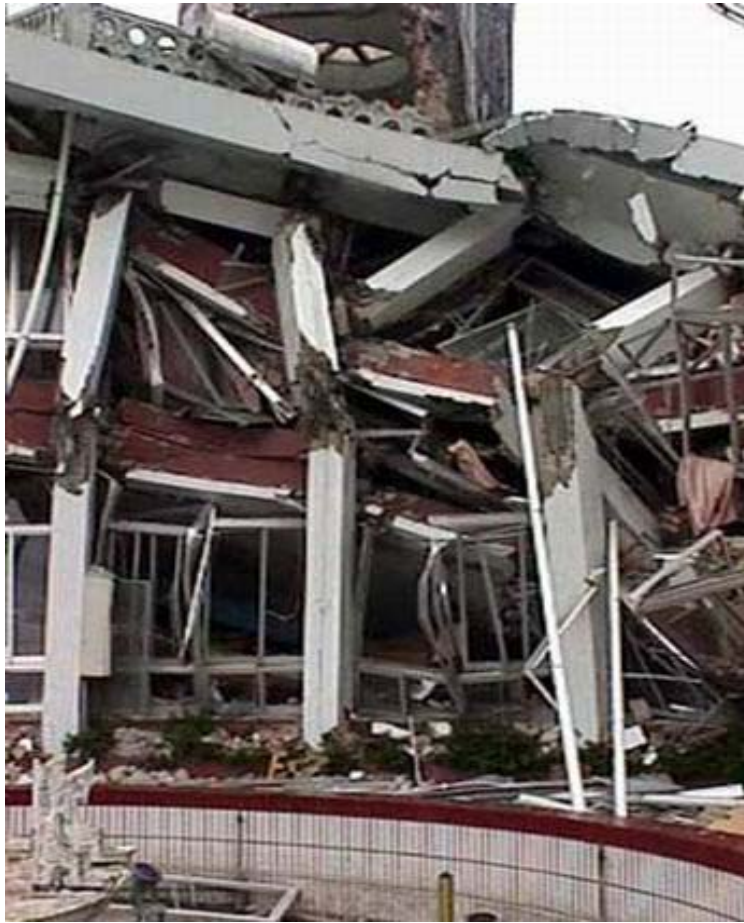
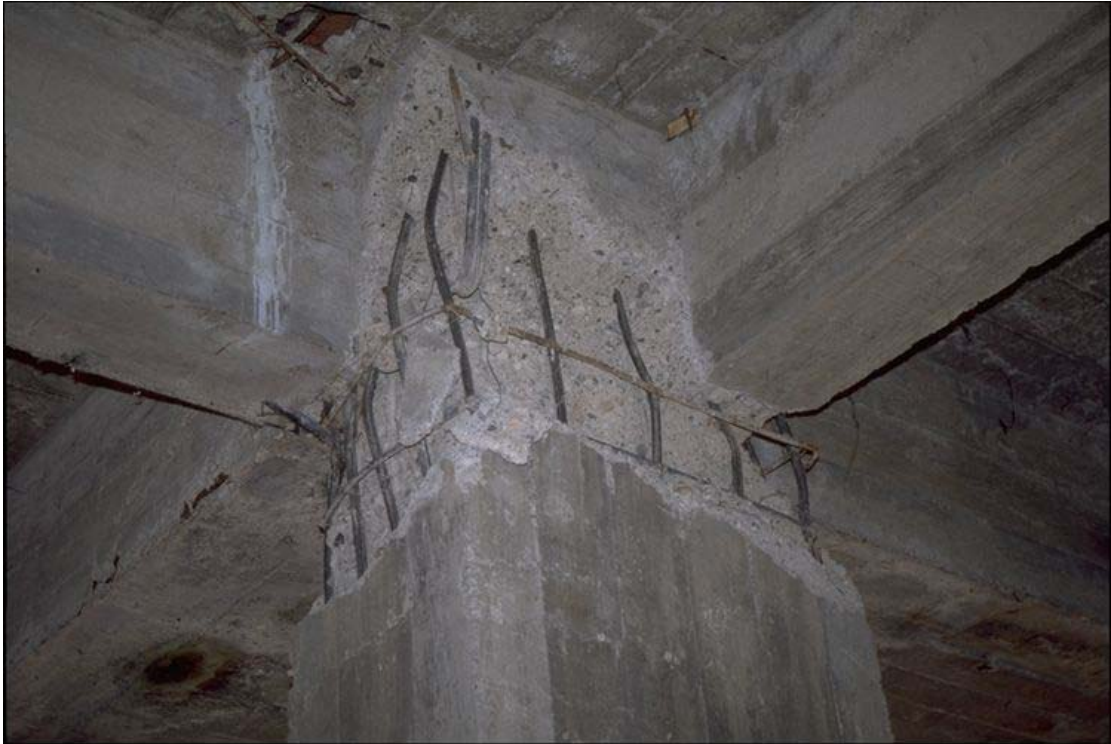
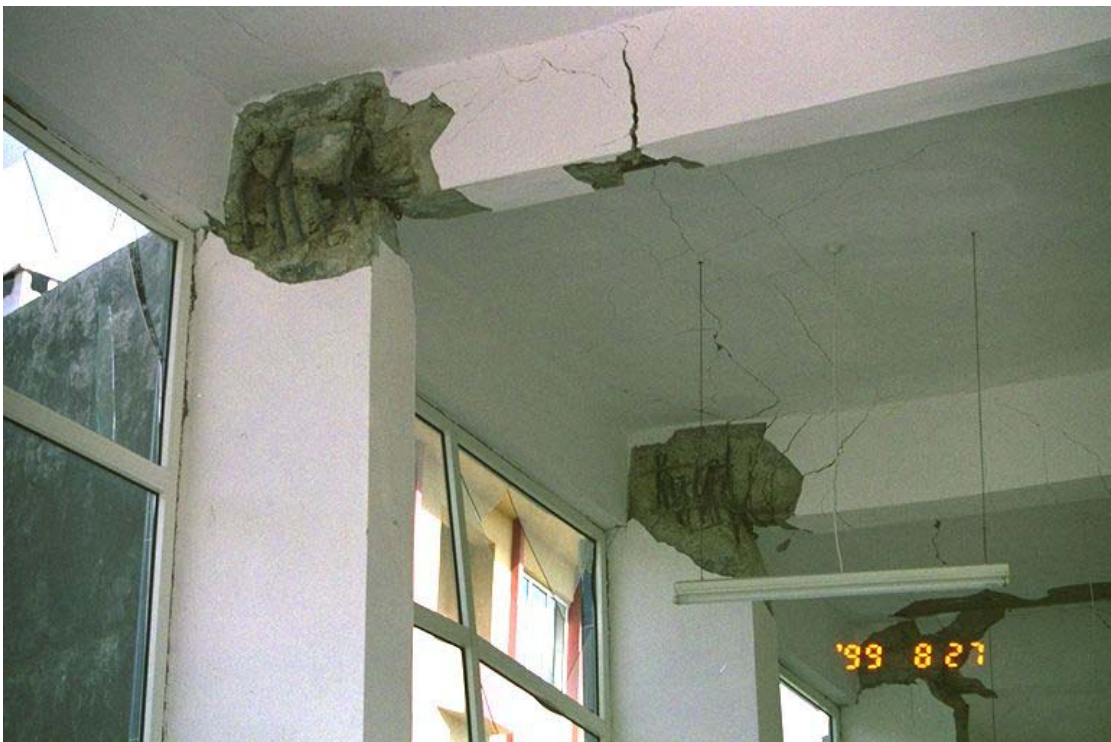
**Figure 1.1 Joint failure in 1999 Chi-Chi, Taiwan earthquake
(NISEE, University of California, Berkeley)**

**Figure 1.2 Joint failure with stairway in 1999 Izmit, Turkey earthquake
(NISEE, University of California, Berkeley)**

**Figure 1.3 Joint failure from below in 1999 Izmit, Turkey earthquake
(NISEE, University of California, Berkeley)**

**Figure 1.4 Multiple joint failures in 1999 Izmit, Turkey earthquake
(NISEE, University of California, Berkeley)**

bi-directional cyclic response. Fig. 1.1 to Fig. 1.4 show some example of damage on the beam-column joint of a structure observed during recent earthquake events

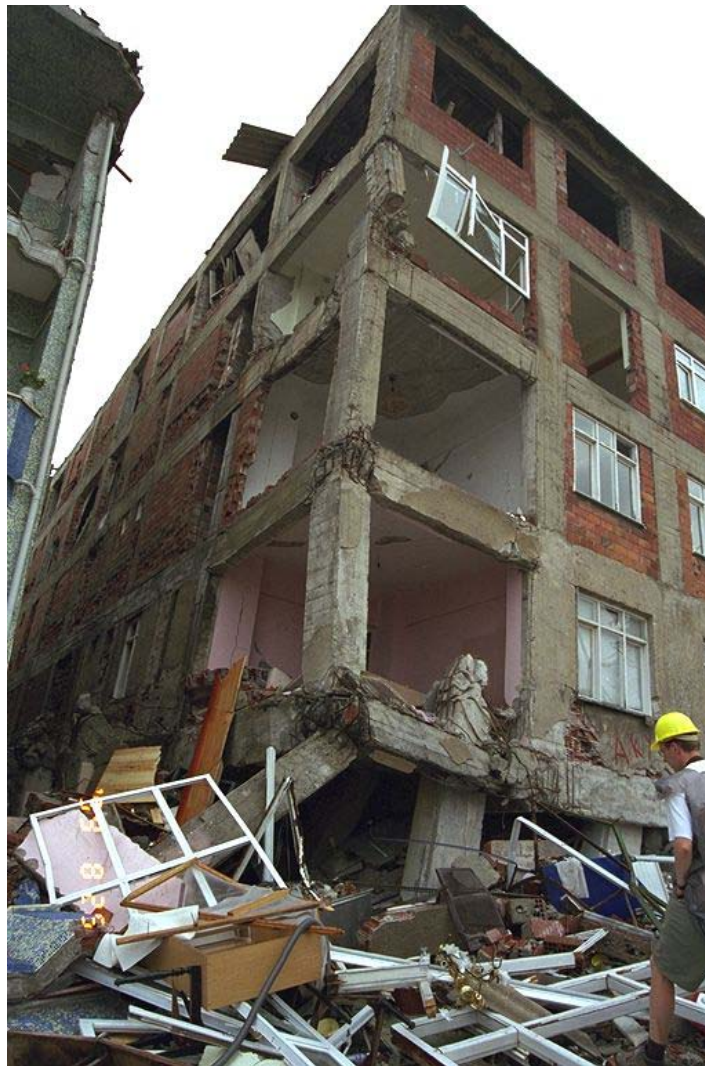
**Figure 2.1 Severe damage on corner joints in 1999 Izmit, Turkey earthquake
(NISEE, University of California, Berkeley)**

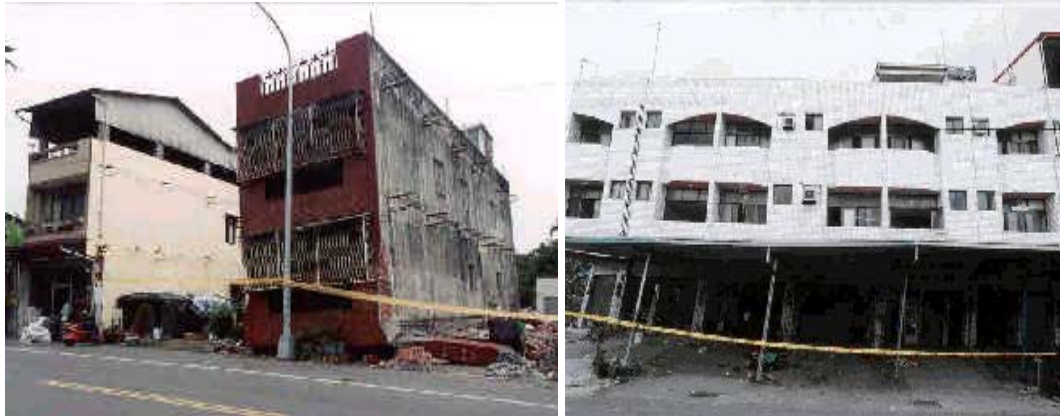
Figure 2.7 Soft-storey mechanism observed in 1999 Chi-Chi Earthquake in Taiwan due to the effect of the use of infills, Uang (1999)

shown in Fig. 2.7. The infill walls were used in the higher storeys while the first storey did not have any infill walls.

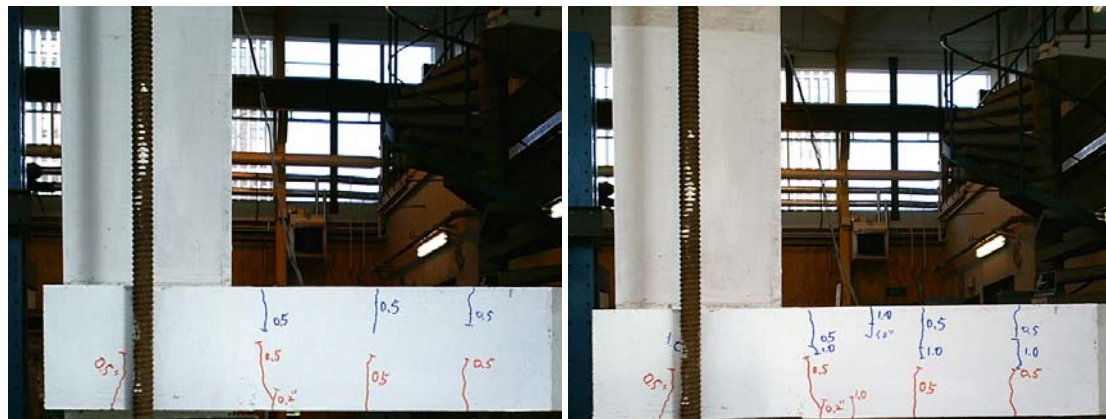
(a) At 0.5% of drift

Figure 4.23 shows the crack development and the final appearance of Unit TSD.
